# HARBOR AREA MANAGEMENT PLAN

## IN-HARBOR BEACH REPLENISHMENT STRATEGY

### Technical Report

June 2009

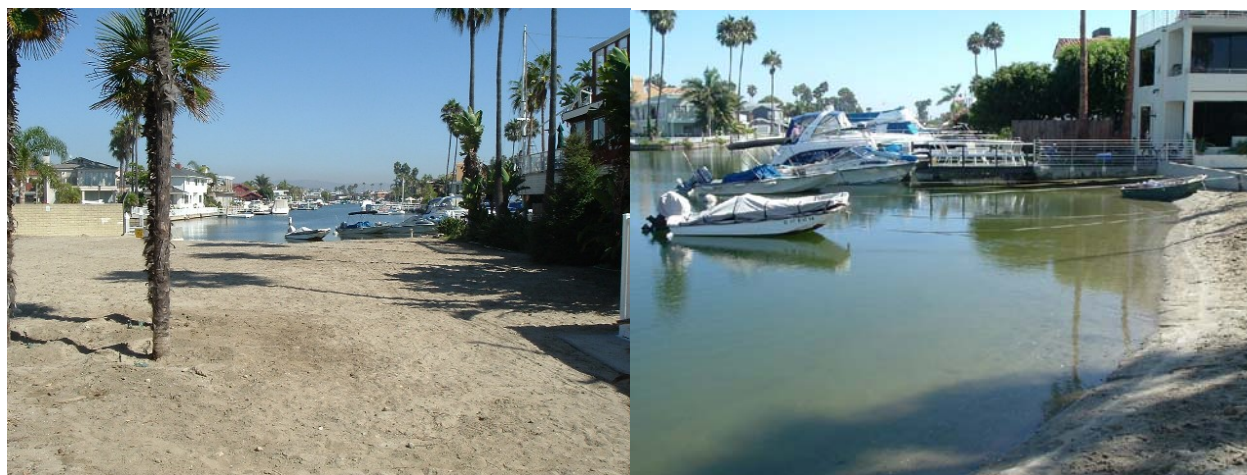
**Figure 3. Channel Place Park**

Channel Place Park is a public beach with a playground and other amenities. Additional sand capacity on the beach is limited by sand retention groins at either end, which function to separate the sandy beach from nearby boat slips. Currently, the beach could accept on the order of tens of cubic yards without overflowing beyond the end groins.

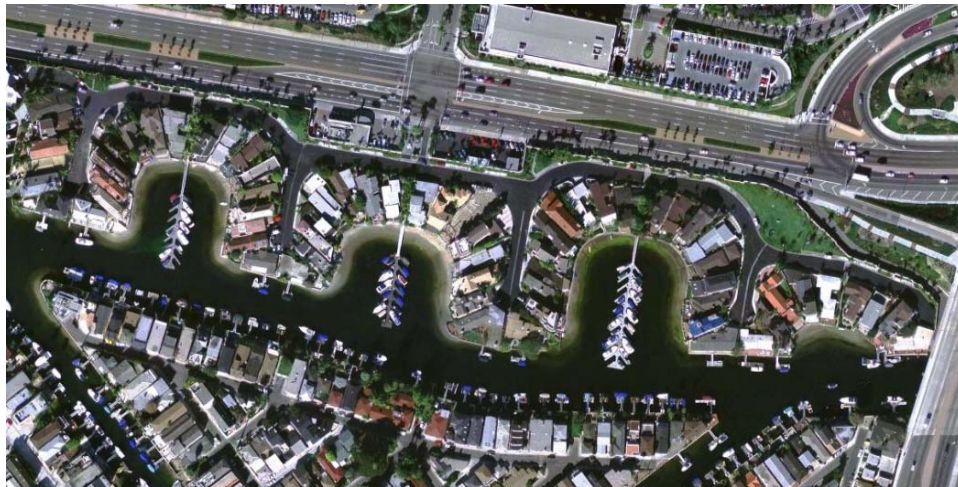
**Figure 4. Balboa Coves**

The four beaches at Balboa Coves are not publicly accessible via land. The beaches were relatively stable between the 2001 and 2006 as determined from aerial photographs. From the aerial photographs, it seems that any replenishment would cause a negative impact on the many boat slips within the coves.

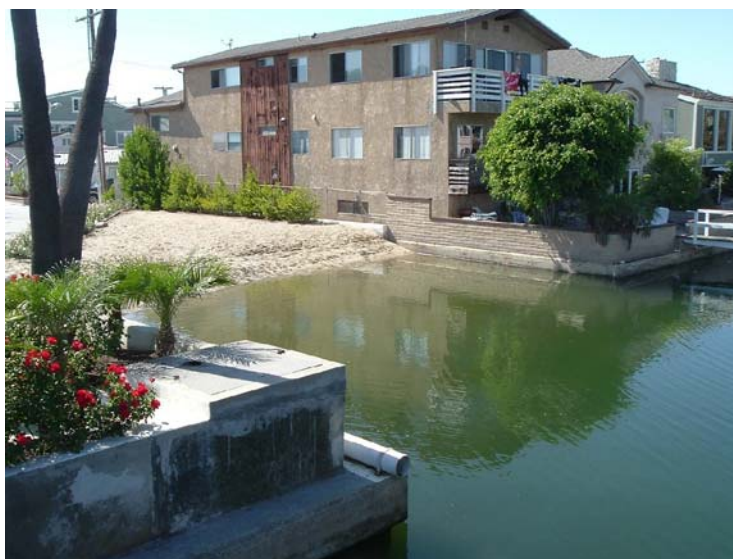
**Figure 5. Beach at Lake Street**

The beach at Lake Street and 38<sup>th</sup> Street is bound on either end by the 38<sup>th</sup> Street Bridge and an impermeable patio, shown in the photo below. Additional sand capacity is available at this beach on the order of tens of cubic yards.

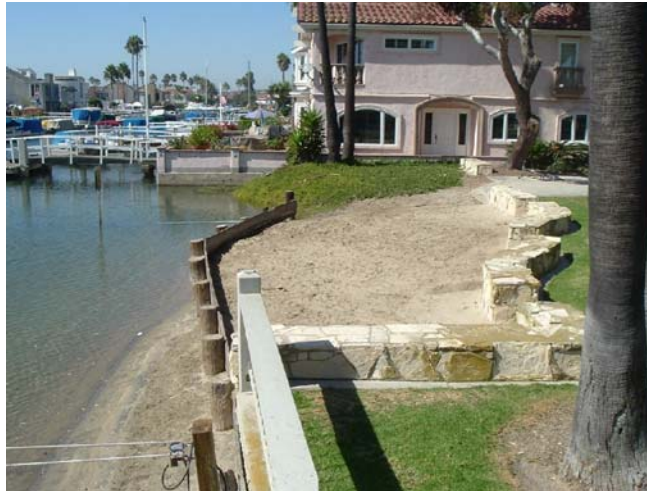
**Figure 6. Beach at Newport Island Park**

This public park is located on the south shore of Newport Island near the intersection of Marcus Avenue and 38<sup>th</sup> Street. All beaches on Newport Island are excluded from replenishment under the RGP. Replenishment can be permitted with additional sediment testing and acquisition of an amendment to the RGP. Due to the nearby boat slips, the beach has a small capacity for additional sand on the order of tens of cubic yards.

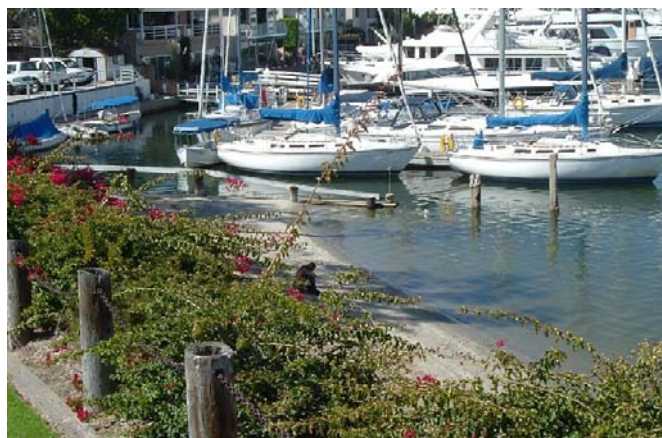
**Figure 7. Beach at Lido Park**

The beach at Lido Park is located on the north-west side of the Via Lido Bridge. It is bounded by a groin on the west and the bridge to the east. The current beach is at capacity. Any additional sand would likely slip around the groin into the nearby boat slips.

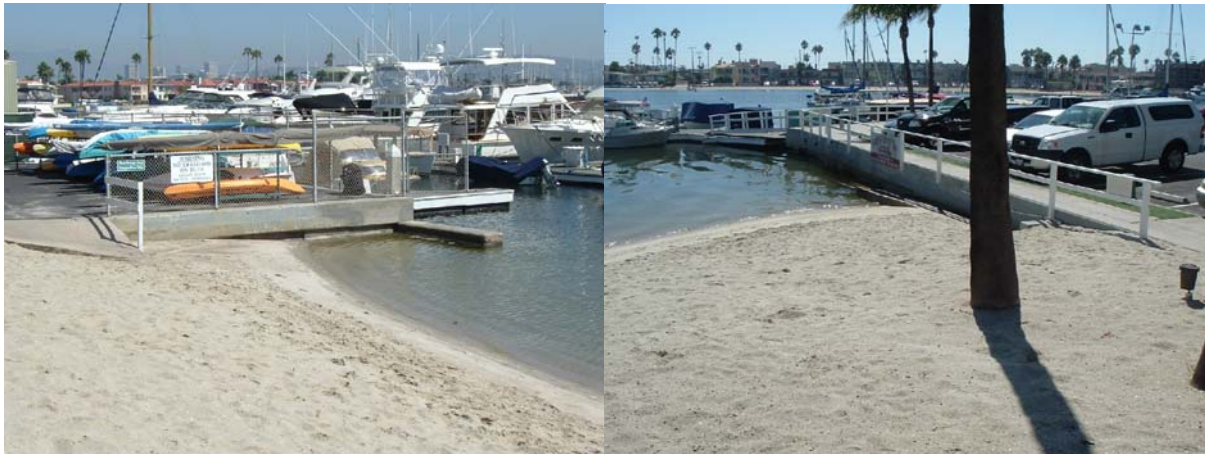
**Figure 8. Beach at Lido Peninsula**

This beach is located on the south east tip of the Lido Peninsula. Based on visual inspection, the sand ranged from very fine at the water line to very coarse at the beach berm. Sand retention groins are located at both ends of this pocket beach to prohibit sand migration out of the beach and into the nearby boat slips. The current beach is at capacity.

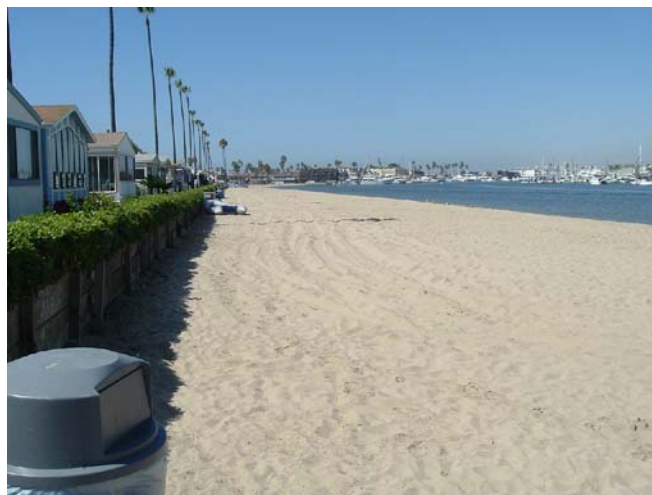
**Figure 9. Beach at Marina Park**

The beach at Marina Park is located between 16<sup>th</sup> Street and 19<sup>th</sup> Street on the north shore of the Balboa Peninsula. This beach can accommodate a relatively large quantity of replenishment sand on the order of hundreds of cubic yards.

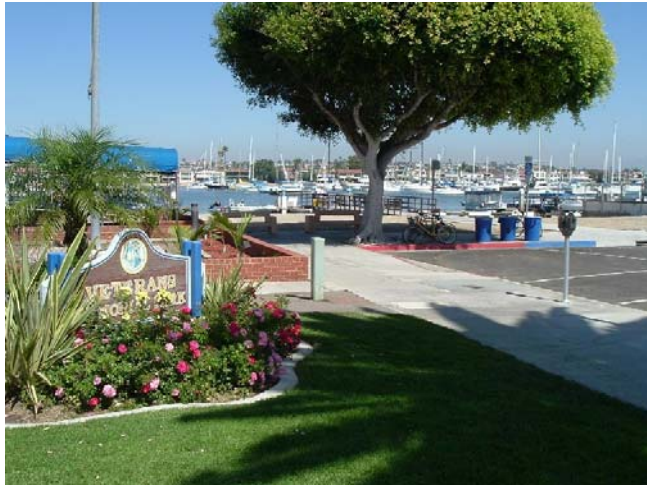
**Figure 10. Beach at 15<sup>th</sup> Street**

No beach replenishment is permissible within 1,000 feet of the 15<sup>th</sup> Street public pier under the RGP. If beach replenishment is desired, additional sediment testing and an amendment to the RGP would be required. The current beach width appears adequate. Any beach replenishment would likely impact the 15<sup>th</sup> St. Pier docks and nearby boat slips.

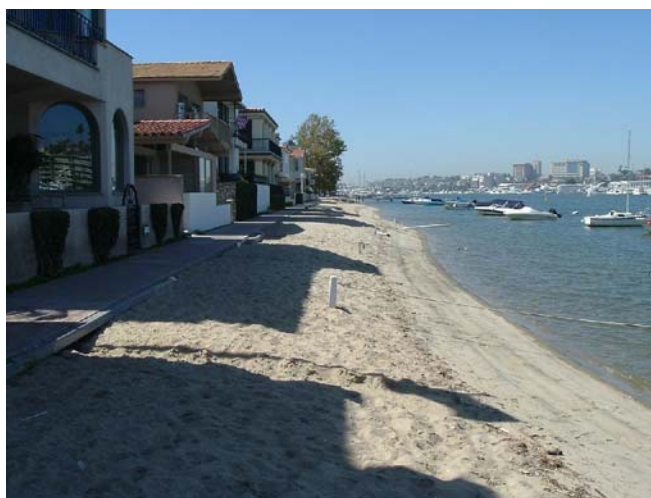
**Figure 11. Beach at Via Lido Nord**

The photo below shows the beach at Via Lido Nord at Koron Street. Additional sand capacity on the beach is limited by sand retention groins, which function to separate the sandy beach from nearby boat slips. The current distance between the high tide water line and the end of the east groin is approximately 5 feet. Any additional sand should be placed in the middle of the beach, far from boat slips at either end.

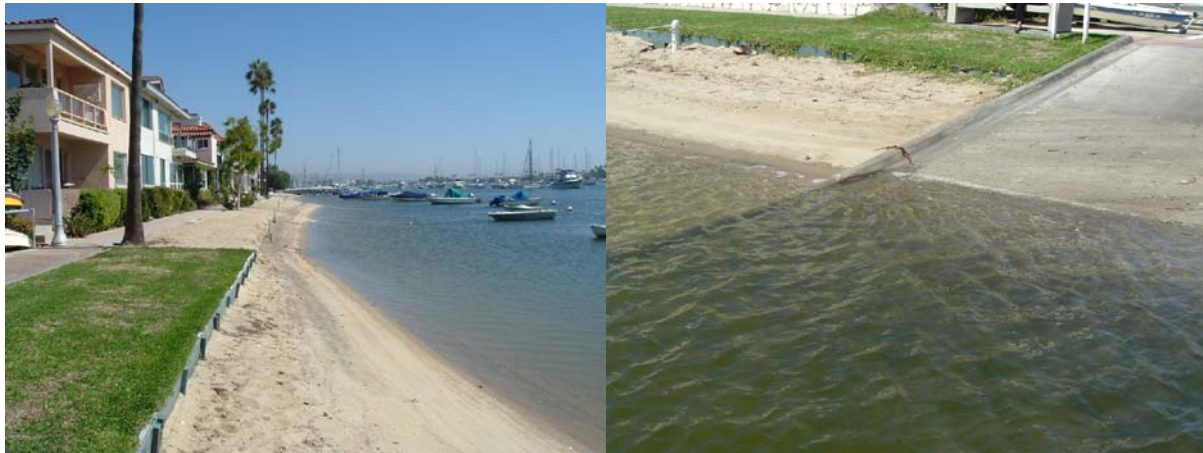
**Figure 12. Beach at Via Lido Soud**

Additional sand capacity on the beach at Via Lido Soud is limited by the size and placement of sand retention structures. The boat launch ramp in the photo below is protected on the edges by small groins which serve to keep sand from migrating onto the ramp surface. The vertical distance from the beach surface to the top of the groin is a few inches. Public land access to this beach is difficult. Visual inspection of the beach sand yielded grain sizes from medium to coarse sand.

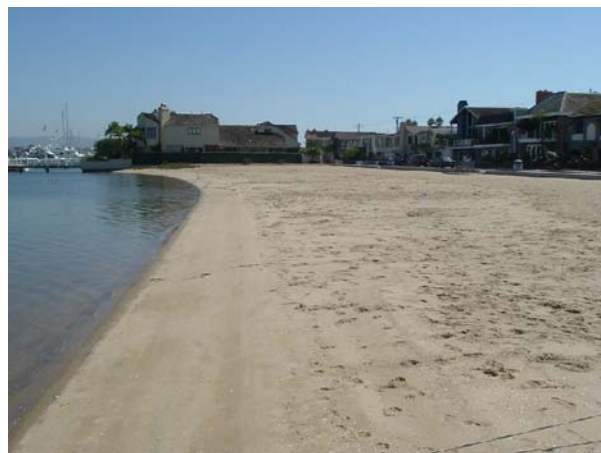
**Figure 13. Beach at 10<sup>th</sup> Street**

There is a public beach at 10<sup>th</sup> Street and West Bay Avenue. It is bound on either end by structures functioning as sand retention groins. The beach is wide, but still has capacity to accept on the order of tens of cubic yards of additional sand without impacting the nearby boat slips.

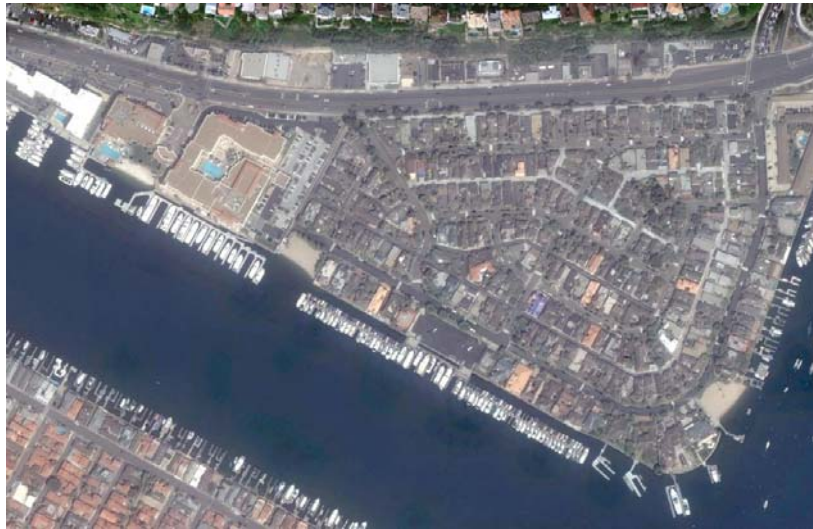
**Figure 14. Crestview and Bayshore Beaches**

Crestview Beach is located at the intersection of Crestview Drive and Bayshore Drive. Bayshore Beach is located on the south east corner of the Bayshore development. These beaches are inaccessible to the public by land. They appear stable, near to eelgrass beds, and bound by boat slips. Any replenishment would have to be small, on the order of tens of cubic yards.

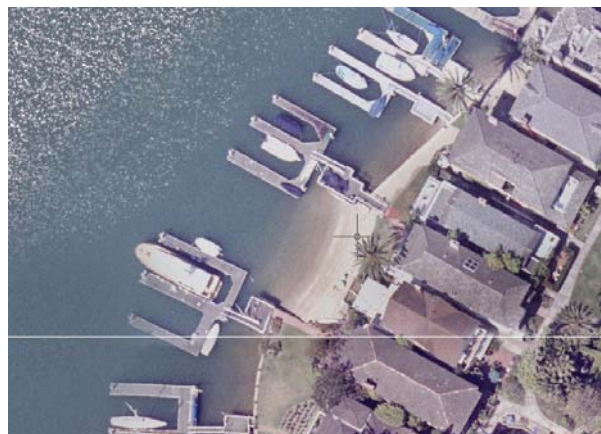
**Figure 15. Beach at Bay Island West**

There is a small beach on the west shore of Bay Island. In 2007, a sand retention wall was proposed for this beach to hold sand up onto the beach and keep it from migrating into the boat slips (Rossmiller, 2007). The beach has no public access, is small, and bound by boat slips, so replenishment capacity is small, on the order of tens of cubic yards.

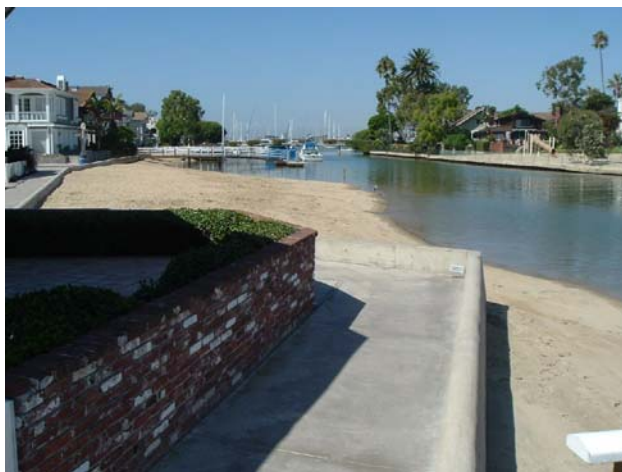
**Figure 16. Beach at Edgewater and Montero Avenues**

The beach near the junction of Edgewater Avenue and Montero Avenue is bound on either end by boat slips and offshore by eelgrass. Nevertheless, there are long stretches between boat slips (hundreds of feet) and the eelgrass beds are located more than 30 feet from possible replenishment locations. Therefore, this could receive hundreds of cubic yards of replenishment sand.

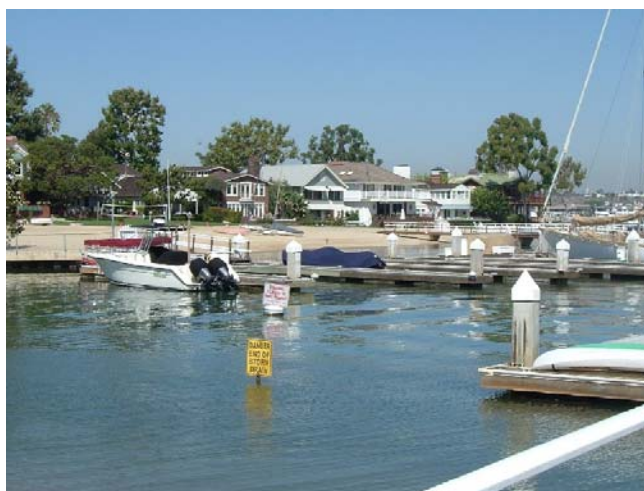
**Figure 17. Beach at Bay Island East**

The beach on the east side of Bay Island is inaccessible to the public by land. This beach has boat slips along the majority of its length, with one open area at the north end. The beach is relatively wide compared to other beaches within the Lower Bay and would likely have a low attendance due to it being located on a private island. It could accept on the order of tens of cubic yards without impacting navigation.

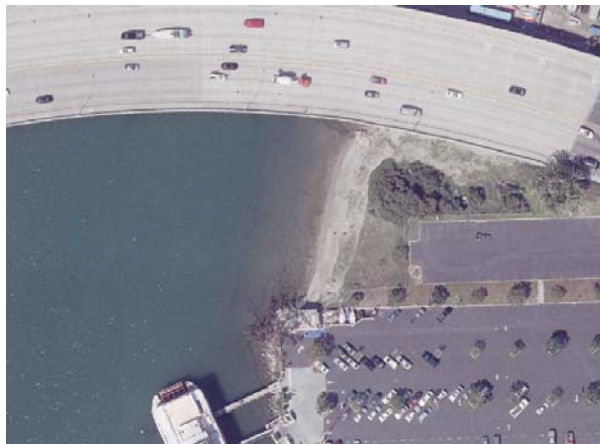
**Figure 18. Beach at PCH Bridge**

The beach just south of the Pacific Coast Highway Bridge is inaccessible to the public by land. It is currently fenced off and occupied by numerous sculling boats (not shown).

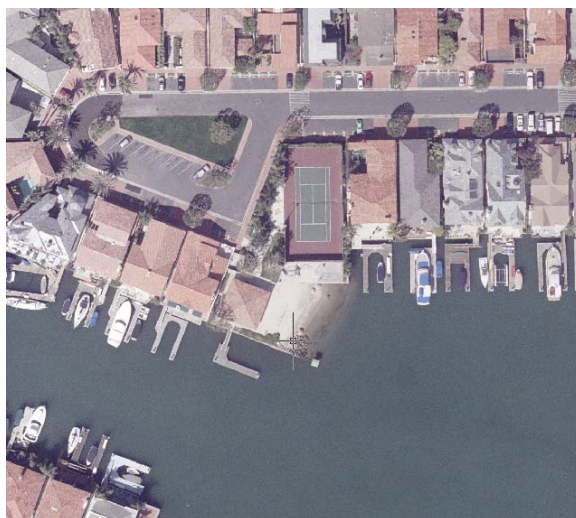
**Figure 19. Beach at Linda Isle**

This beach is inaccessible to the public by land. From aerial photographs it appears that no additional sand could be placed without impacting navigation in nearby boat slips.

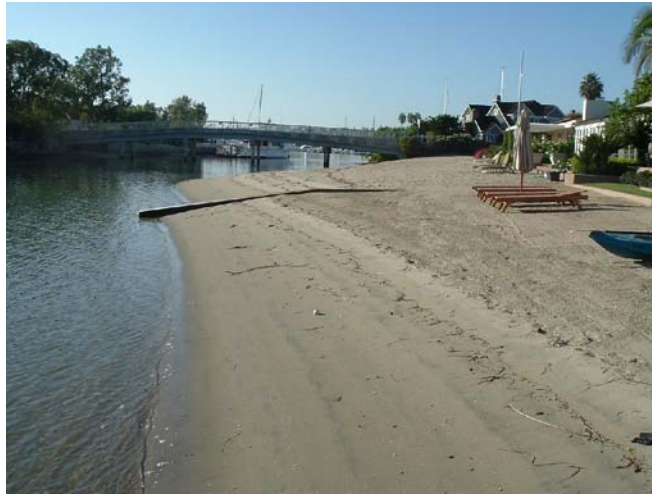
**Figure 20. Beach at Beacon Bay**

This beach is inaccessible to the public by land. This beach could accept hundreds of cubic yards of sand without negatively impacting navigation or boat slips.

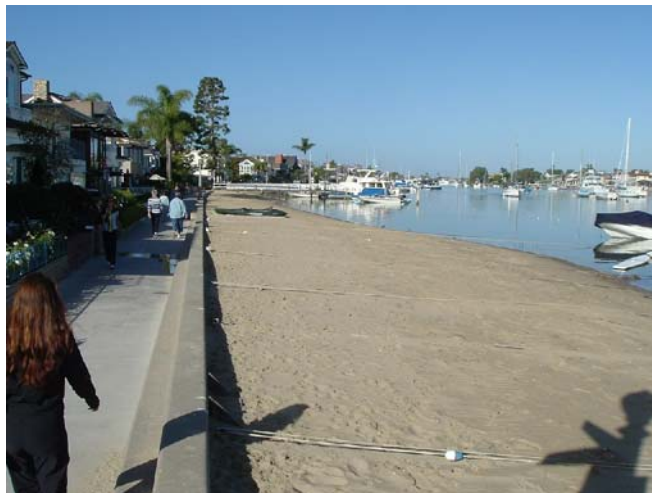
**Figure 21. Beach at Ruby Street, North Bay Front, St. Looking West**

1,500 cubic yards was replenished on Ruby Beach on the North Bay Front as part of a 2007 dredging effort that removed a total of 7,000 cubic yards from Channel Reef docks. This beach could receive additional sand at specific locations.

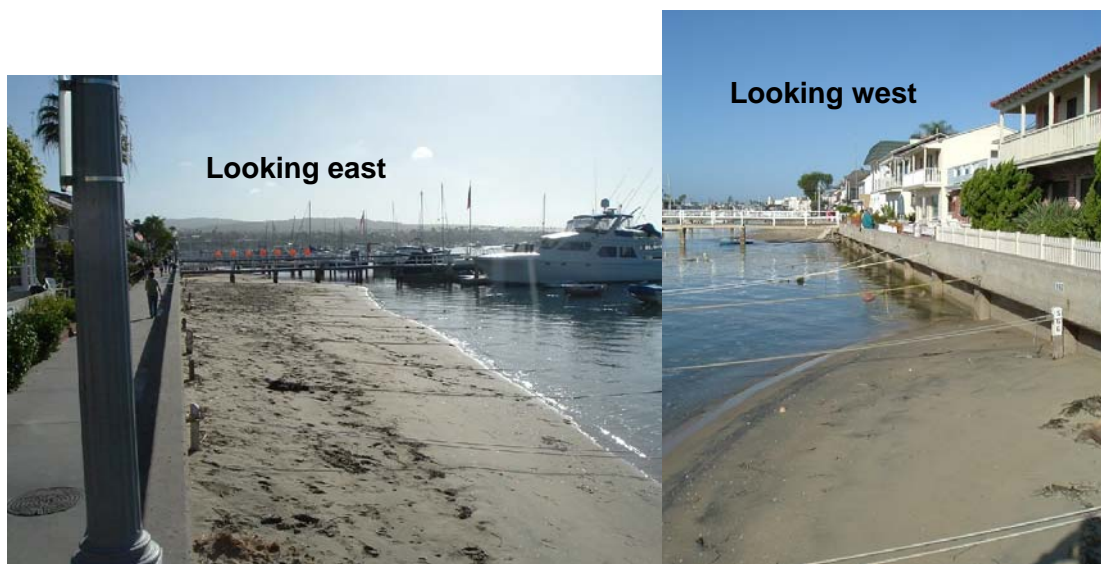
**Figure 22. Beach at Ruby Street, South Bay Front, Looking East and West**

South Bay Front stretch along the south and west sides of Balboa Island. A 2002 economic study concluded that if beach widths were doubled to an average of thirty feet, the average increase in attendance would be between 7% and 9% (King & Symes, 2002). Also, any significant increase in beach width would cause a negative impact to navigation in the boat slips. There are however erosion hot spots, such as west of Ruby St. that would benefit from replenishment.

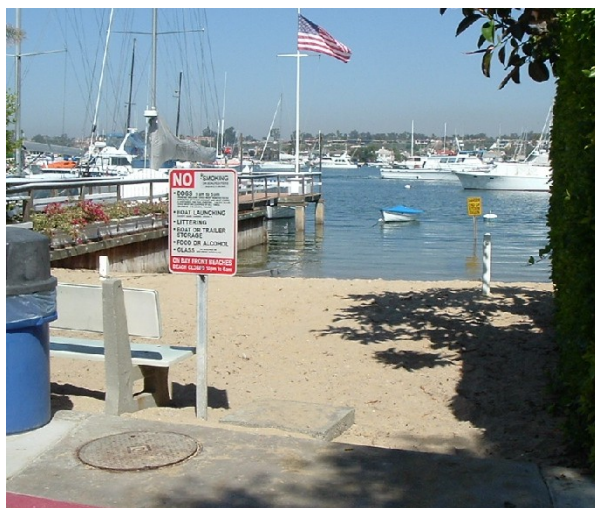
**Figure 23. Typical Street End Beach Along E. Bay Avenue**

The beaches along E. Bay Avenue consist of mainly street ends as shown in Figure 23 below and beaches fronting private homes. The street ends are bound on both sides by sand retention groins which serve to separate sand from the nearby boat slips. Most of the beaches along E. Bay Ave. are at capacity. Minor replenishment projects of tens of cubic yards may be acceptable.

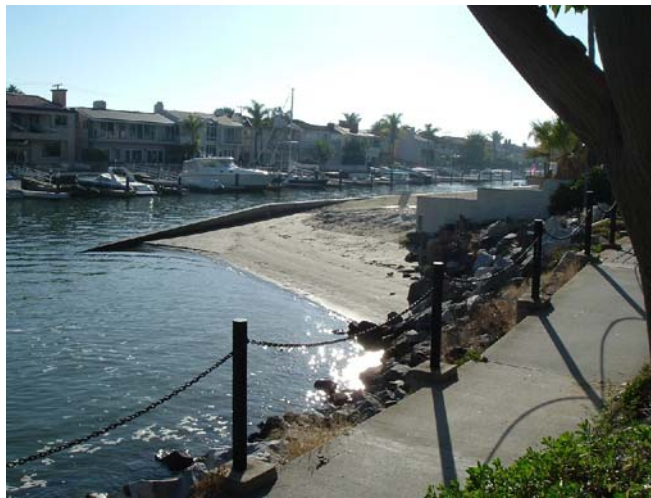
**Figure 24. Beach at Promontory Bay**

The beach at Promontory Bay is just south of Bayside Drive and east of Harbor Island Road. There is a sign indicating that it is a private beach. This beach is excluded from replenishment under the RGP. Replenishment can be permitted with additional sediment testing and acquisition of an amendment to the RGP. The beach currently is at capacity. Sand replenishment beyond a few cubic yards would likely overspill the sand retention groin shown in Figure 24.

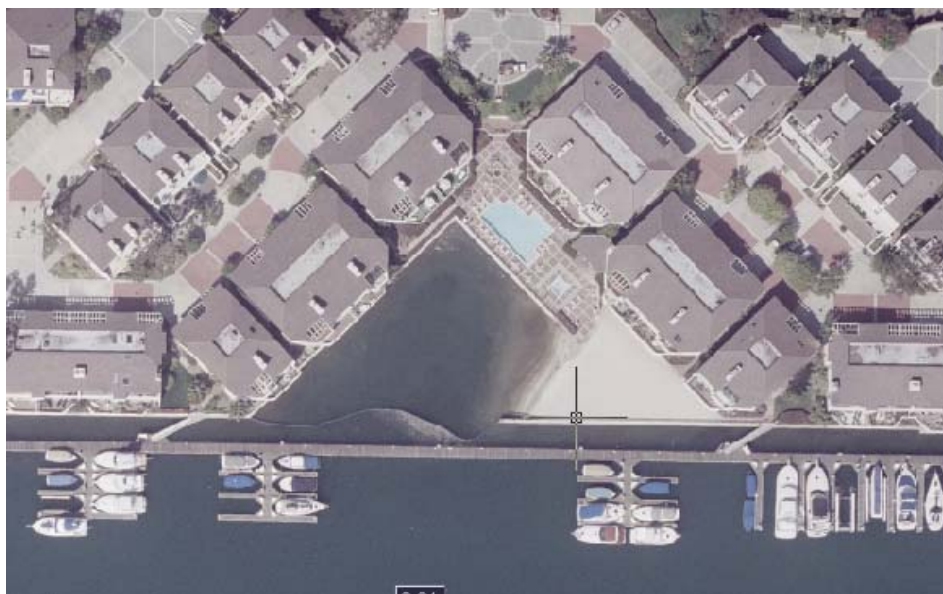
**Figure 25. Beach at Bayside Cove**

The beach at Bayside Cove is inaccessible to the public by land or water. From the aerial photographs it appears that additional sand could be placed without impacting boat slips.

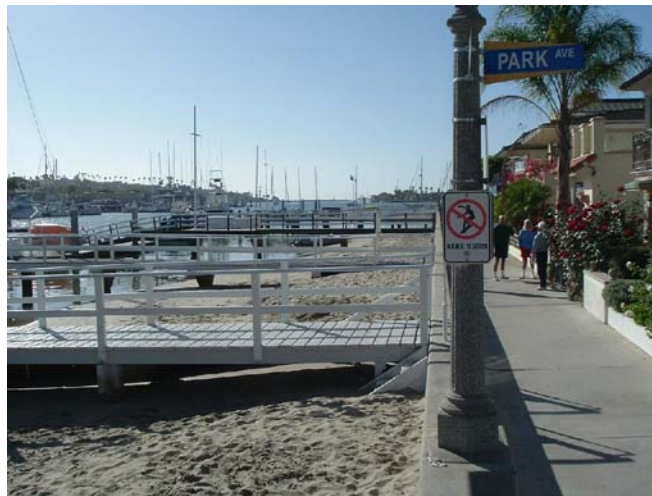
**Figure 26. East Bay Front**

The beach along East Bay Front is variable in width and underlies many boat dock ramps. Any beach replenishment would have to be of small quantities at specific locations. The proximity of boat slips would be a limiting factor to replenishment.

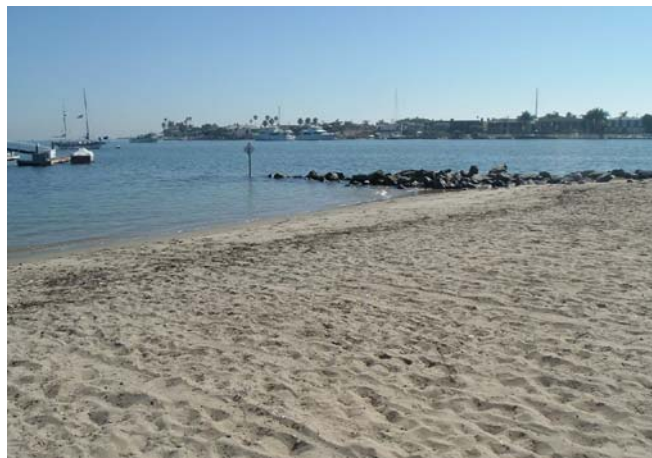
**Figure 27. Harbor Patrol Beach**

The beach near the Harbor Patrol office in Corona del Mar is sometimes called Interceptor Beach. This name describes its function, which is to intercept, or trap, migrating sand, keeping it from penetrating farther into the harbor and boat slips (Brodeur, 2007). By design, this beach would not be a receiver of replenishment sand, rather a source.

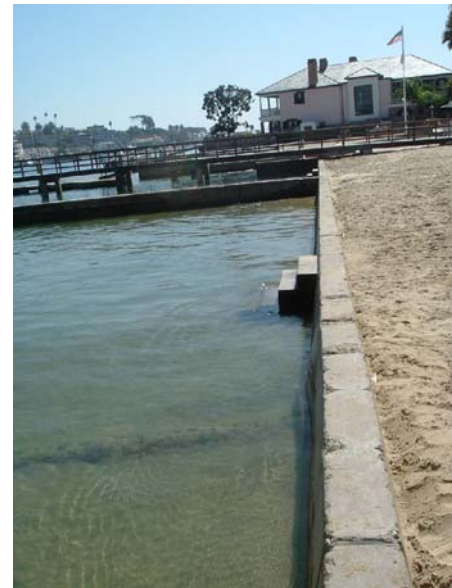
**Figure 28. Beach at M Street**

A public beach is located at M Street and Channel Road on the tip of the Balboa Peninsula. This beach has a flat sandy platform maintained by a concrete, shore parallel retaining wall. On the bay side of the wall is a low sandy beach accessed by concrete steps. The bay side beach is submerged at high tide as shown in the figure below. Some capacity for additional sand exists, but is limited by the nearby boat slips and eelgrass.

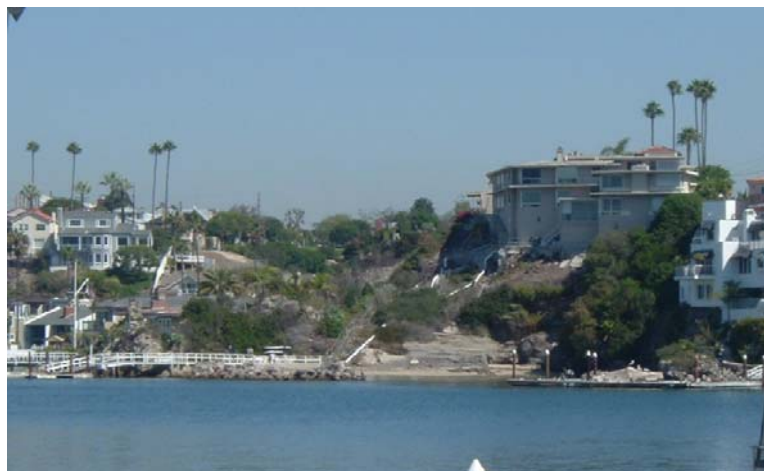
**Figure 29. Carnation Cove**

Carnation Cove has an erosive beach (Miller, 2007). The beach is inaccessible to the public by land. Comparing the 2001 and 2006 aerial photographs showed the beach increased from no beach in 2001 to a 10 foot wide dry beach in 2006.

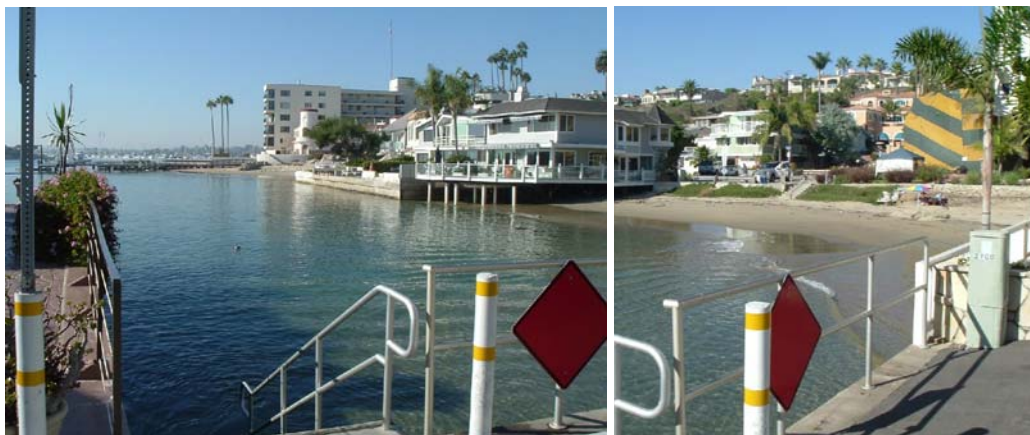
**Figure 30. China Cove**

The beach at China Cove is erosive (Miller, 2007). Between the 2001 and 2006 aerial photographs, the beach width eroded by approximately 20 feet. Since then, this beach received about 985 cubic yards of replenishment in the summer of 2007 under the RGP. The purpose of the replenishment project was to provide additional dry beach for recreation and to help protect the bulkhead and exposed piles within China Cove. The replenishment source was 500 feet north of China Cove. The beach has since returned to a narrow, eroded condition as shown in the photos below.

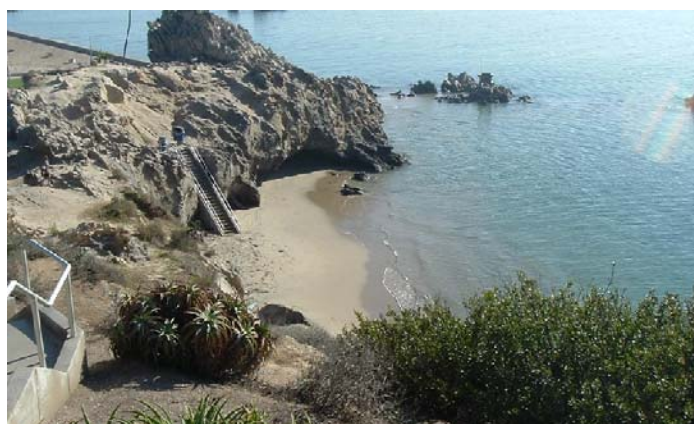
**Figure 31. Pirate's Cove**

Pirate's cove has a popular beach due to the easy access and plentiful parking. Of all the beaches in the Lower Bay, this beach is the most exposed to open ocean swell. The beach is consistently narrow as observed in the 2001 and 2006 photos as well as the recent site visit. It is likely that any replenishment to this beach would erode quickly, migrating further into the bay.

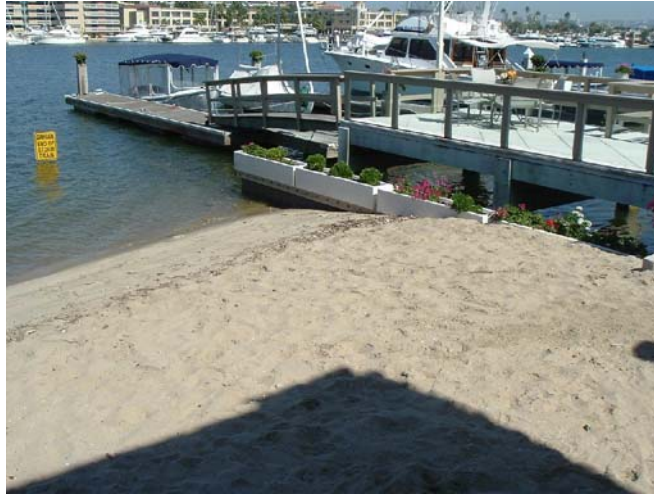
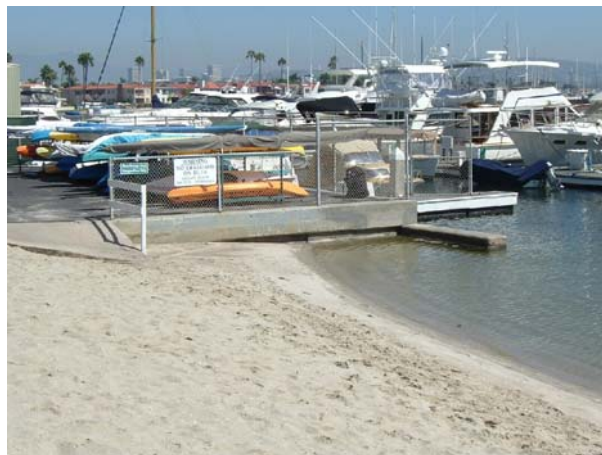
The combined desire for relatively wide beaches and functional boat slips has resulted in the need for near constant beach maintenance. In many cases the maintenance is essentially pushing sand from below the boat slips, uphill to the beach and repeating on a regular basis. In addition, sand retaining groins are prevalent throughout the Lower Bay. Two examples are shown in Figures 33 and 34 below. The groins function to separate the sandy beach from boat slips, reducing the maintenance frequency.

**Figure 33. Groin Separating Sandy Beach from Boat Slips at Via Lido Nord**

**Figure 34. Groin Separating Sandy Beach from Boat Slips on Lido Peninsula**
